Verification of repair effect of bridge deck using UHPFRC (J-THIFCOM)

Keywords: Japan - Thixotropic Hardening Impermeable Fiber Reinforced Composite, deterioration, rehabilitation, loading test

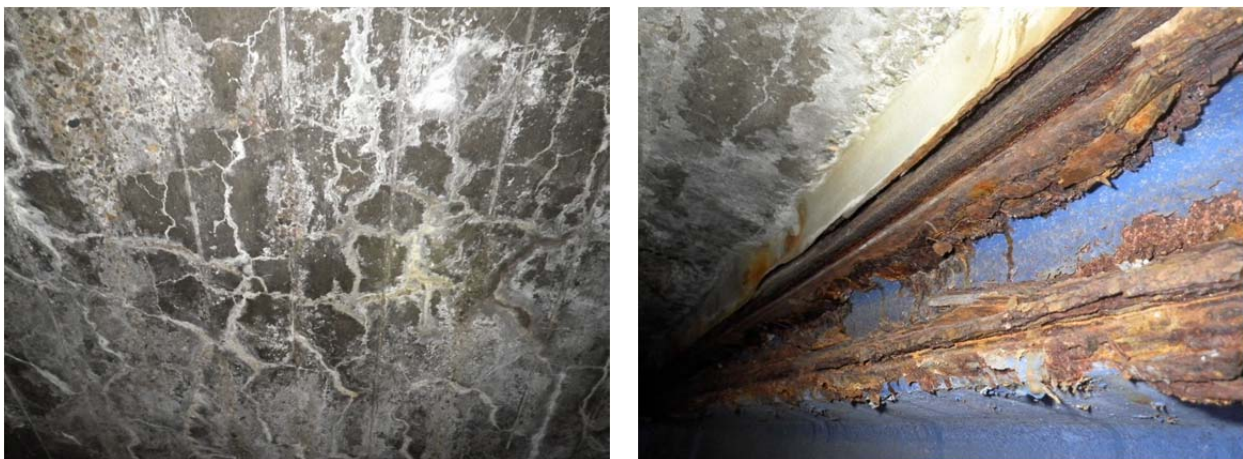
Figure 2: Damaged concrete decks

Following the completion of the main lanes in 1962 and a widening lane in 1981, the Bridge Inspection Report noted some damages with surface spalling and exposed steel reinforcement in concrete walls and decks, and some major crack propagation at approximate concrete slabs. Moreover, it was observed that the condition of deck deteriorated by the cracks and ingress of moisture, causing the formation of efflorescence. It was also found that the leakage, together with efflorescence from the cracked concrete had caused extensive deterioration in some segments of the concrete surface. Figure 2 shows the damaged concrete decks.

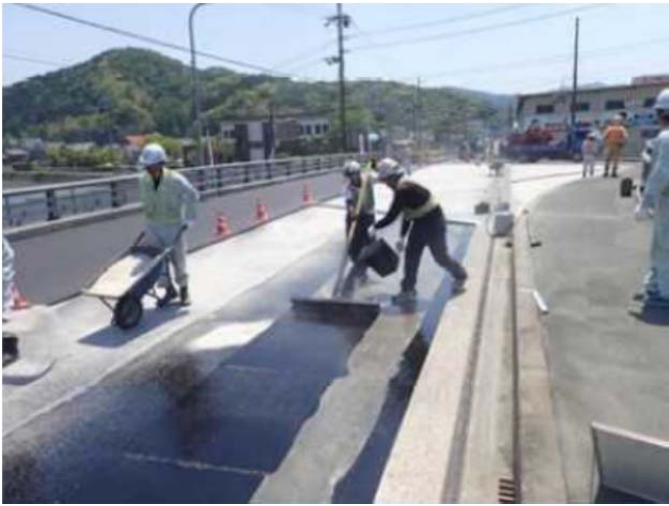
Figure 9: Apply J-Primer on the surface area

were applied on the surface area to fill the surface voids, to waterproof during pavement construction, and to generate adequate bond between an existing pavement surface and a new pavement surface (Figure 8). Finally, the deck surface was finished by paving an asphalt overlay. The completion of pavement is given in Figure 9.

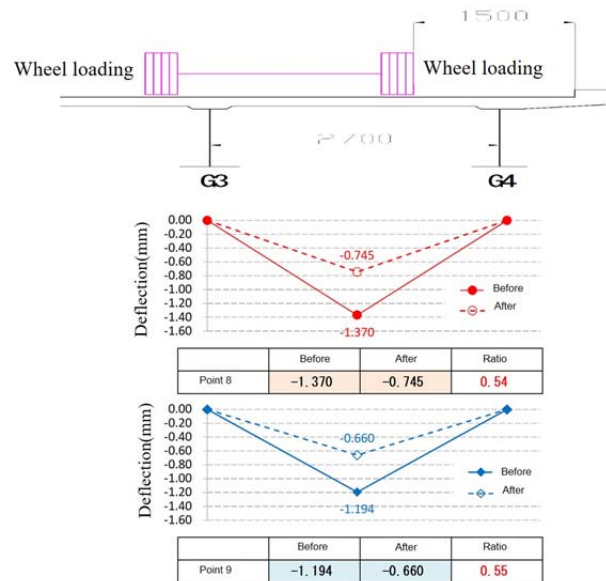
Figure 13 Deflection of deck before and after repairing

Figure 12 presents that evolution of deflection curves at span before and after repairing. The experimental results indicate that the deflection curves obtained after repairing depend on the strength of J-THIFCOM and testing condition. Comparisons of the results obtained from before and after repairing, the value of deflection at point 8 and point 9 decreased from -1.37 mm to -0.745 mm and from -1.194 mm to -0.66 mm, respectively. This difference in behavior was clearly revealed that the performance of J-THIFCOM on the deck deflection was improved. Based on these results, it was concluded that after the deck was repaired, J-THIFCOM provided the sufficient strength for deck to restrict the deflection from heavy loads. The changing of deck deflection after repairing was approximately 45 % less than the value of deck deflection before repairing.
